## Burgess Inspection Group

**REPORT NUMBER** 170701241  
**INSPECTION DATE** 07/01/2024

# PROPERTY INSPECTION REPORT FORM

3504 Villanova Street, Dallas, TX 75225

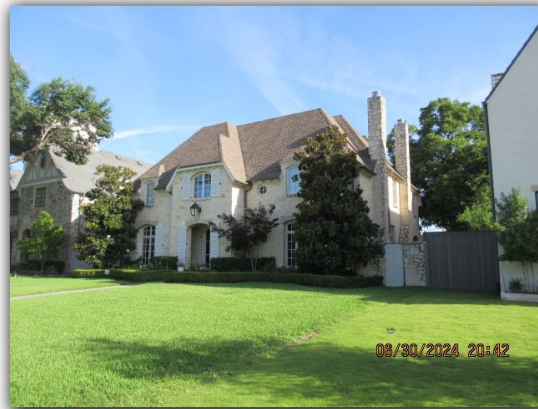
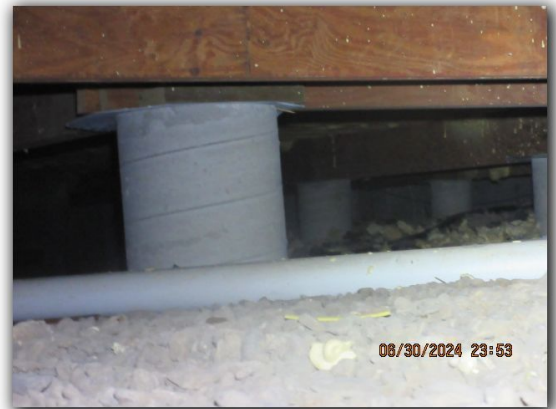
✓ No evidence of excessive movement or structural failure observed at this time. Small random cracks, separations, and other similar signs indicate some movement due to type of foundation, age, consolidation, and soil and drainage characteristics.

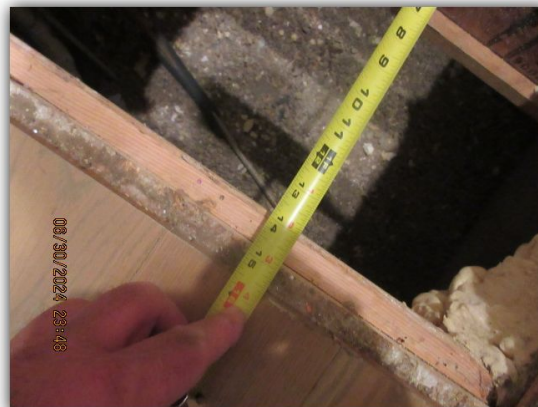
✗ Crawlspace access hole is too small. The access hole should be a minimum of 18 x 24 inches.

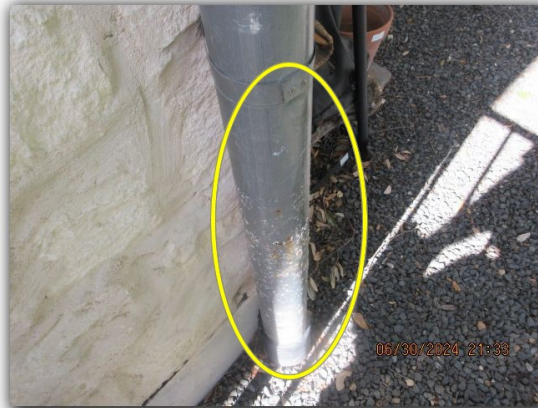
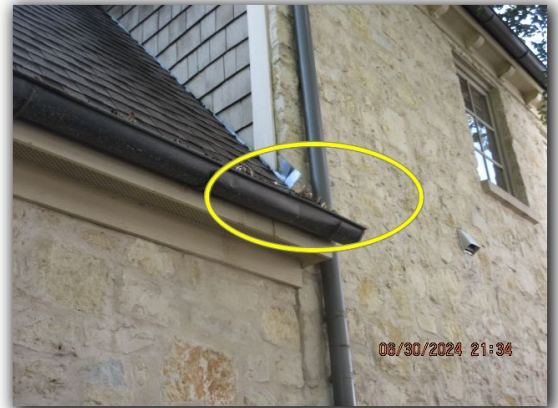
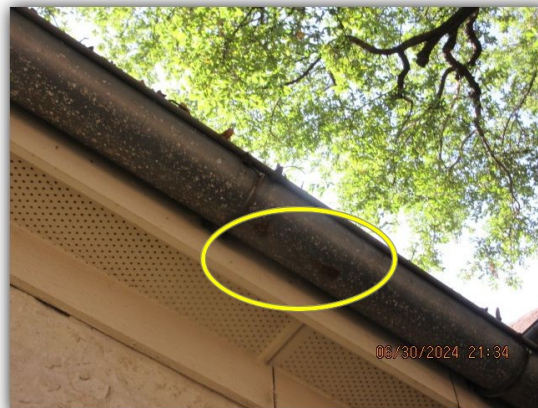
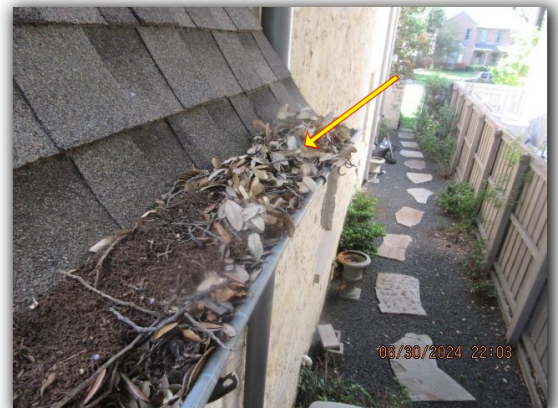
- ✗ Drainage slope at the perimeter of foundation is essentially flat or not well defined.
- ✗ The current slope appears to negative (move water towards the home) at the left side.
- ✗ Gutters and downspouts are rusting and appear to be leaking.
- ✗ Gutters are full of debris and need cleaning.

- ✗ Drainage slope at the perimeter of foundation is essentially flat or not well defined.
- ✗ The current slope appears to negative (move water towards the home) at the left side.
- ✗ Gutters and downspouts are rusting and appear to be leaking.
- ✗ Gutters are full of debris and need cleaning.

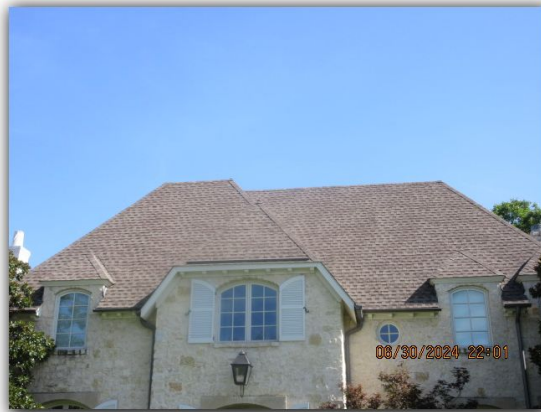
- X** Recommend having the roof evaluated for condition, / serviced as regular ongoing maintenance / repaired or discover the cost of possible repairs by a qualified roof specialist.
- X** Observed what appears to be "scuffed" shingles. This is likely the result of previous foot traffic.
- X** Surface granules on the composition shingles are worn/thinning.
- X** Trees near the structure need to be trimmed at least 5 feet away from the roof.
- X** Debris (leaves, limbs) needs to be cleared from roof, especially from valleys.
- X** Exposed nail heads and/or staples at ridges and/or flashing areas need to be sealed with caulk.
- X** Discolored shingles at some places.

- ✗ Recommend having the roof evaluated for condition, / serviced as regular ongoing maintenance / repaired or discover the cost of possible repairs by a qualified roof specialist.
- ✗ Observed what appears to be "scuffed" shingles. This is likely the result of previous foot traffic.
- ✗ Surface granules on the composition shingles are worn/thinning.
- ✗ Trees near the structure need to be trimmed at least 5 feet away from the roof.
- ✗ Debris (leaves, limbs) needs to be cleared from roof, especially from valleys.
- ✗ Exposed nail heads and/or staples at ridges and/or flashing areas need to be sealed with caulk.
- ✗ Discolored shingles at some places.

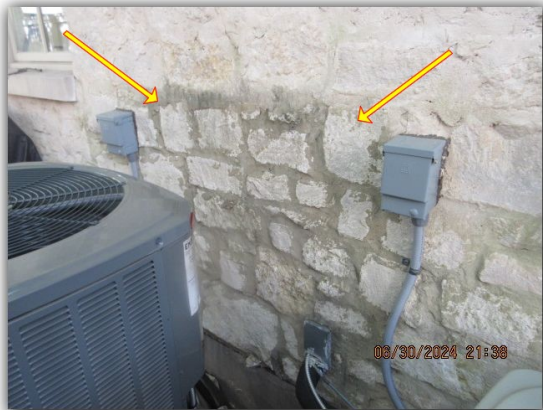
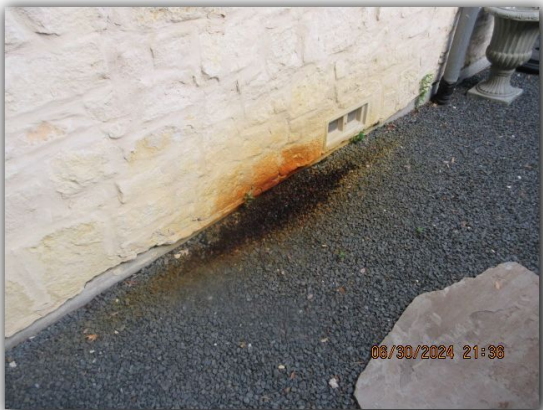
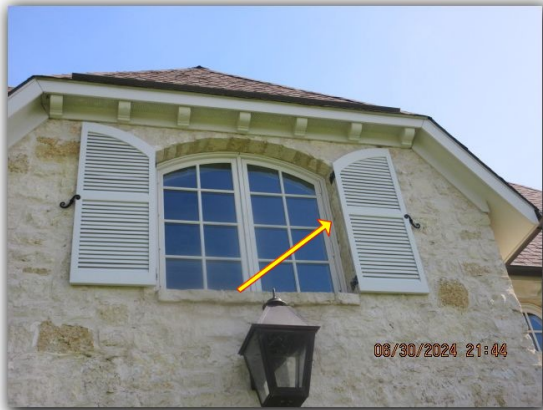
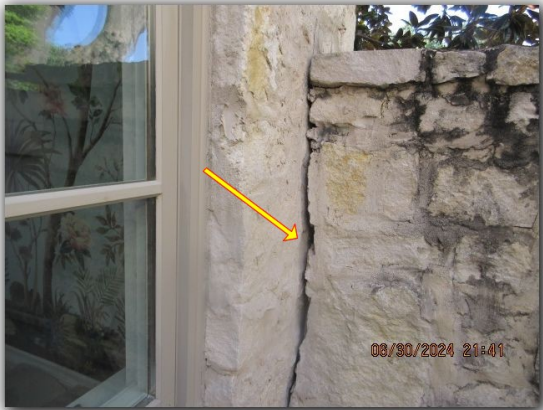
- ✗ Observed previous repairs to exterior masonry.
- ✗ Observed peeling paint at the garage wall.
- ✗ The header trim at the garage door opening is sagging. The resulting gap should be sealed.

- ✗ Discolored mortar at more than one area of the exterior.
- ✗ Keep vegetation away from exterior walls; these are highways for insect and pest infiltration. Hedges should be trimmed at least 1 foot away from exterior walls.

- ✗ Rusty water stains on the wall at left side. This is the result of a previous leak of condensate/water coming from the attic unit overflow drain pan.

- ✗ Dark stains on the wall at more than one place. Consistent water running on wall can lead to water penetration.
- ✗ Masonry wing walls at the front of the house are pulling away from the main structure.

- ✗ Caulking needed at/or around some window frames. (example: front upper)
- ✗ Exterior wood siding/trim is weathered and needs painting / sealing.
- ✗ Pests have damaged the wood material with chewing at eaves.

- ✗ Observed previous repairs to exterior masonry.
- ✗ Observed peeling paint at the garage wall.
- ✗ The header trim at the garage door opening is sagging. The resulting gap should be sealed.

- ✗ Discolored mortar at more than one area of the exterior.
- ✗ Keep vegetation away from exterior walls; these are highways for insect and pest infiltration. Hedges should be trimmed at least 1 foot away from exterior walls.

- ✗ Rusty water stains on the wall at left side. This is the result of a previous leak of condensate/water coming from the attic unit overflow drain pan.

- ✗ Dark stains on the wall at more than one place. Consistent water running on wall can lead to water penetration.
- ✗ Masonry wing walls at the front of the house are pulling away from the main structure.

- ✗ Caulking needed at/or around some window frames. (example: front upper)
- ✗ Exterior wood siding/trim is weathered and needs painting / sealing.
- ✗ Pests have damaged the wood material with chewing at eaves.

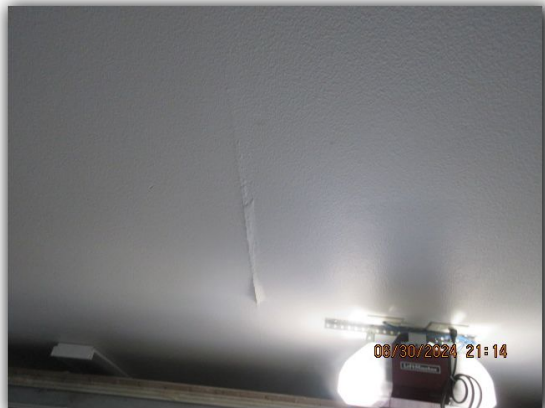
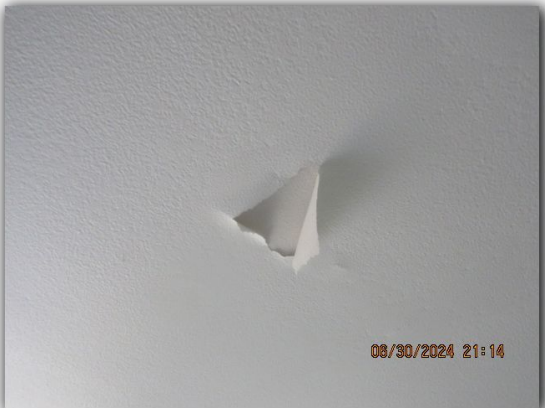
- ✗ Observed small sheetrock cracks in some of the ceilings (example: garage).
- ✗ Paint is peeling at the garage ceiling..
- ✗ Floor tiles are cracked in the upstairs bathroom right and primary bathroom.

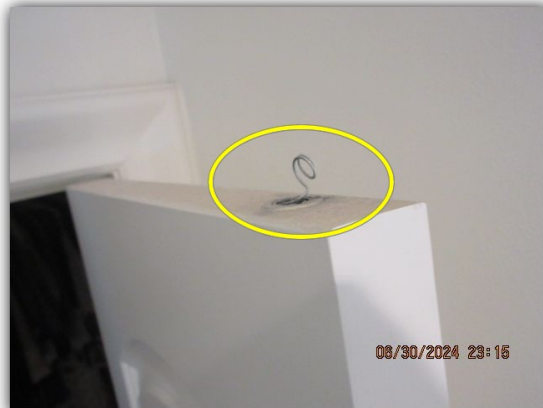
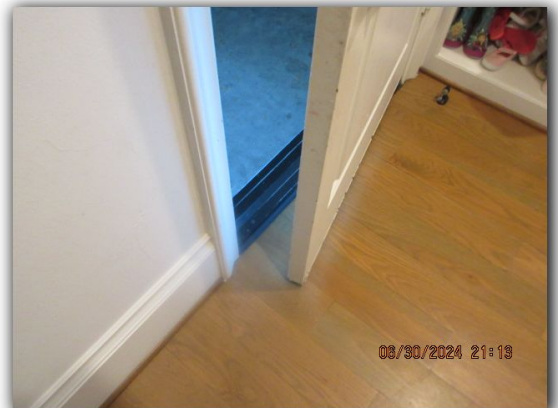
- ✗ The top of the door ball-latch(s) is damaged / not operating properly at the primary closet.
- ✗ The door to the garage is not self-closing as is currently required.
- ✗ Door(s) not latching (misaligned with striker plate) at the powder bath.

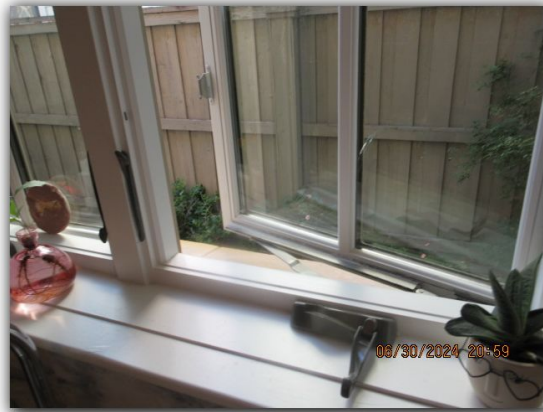
**Deficient Item(s): Windows**

- ✗ Window screens are missing / not installed.
- ✗ Window crank handles are missing at several locations, mostly upstairs. These windows were not opened today.

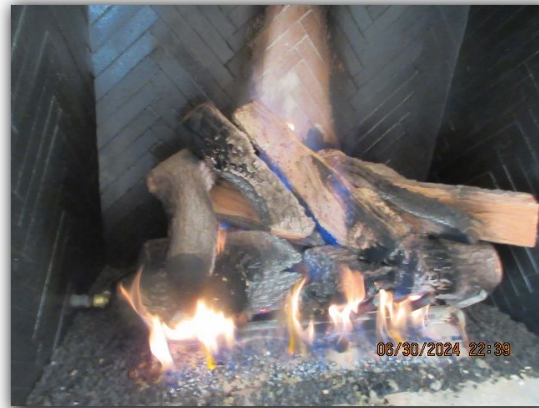
- ✓ Fireplace damper operates to control and firebox appears to be in good condition.
- ✓ The top chimney cap(s) was not accessible and was not observed.

- ✗ Dampers are not fitted with a blocking clamp which is required when gas logs with a gas control valve are present. (indoor fireplaces) The small opening would allow carbon monoxide to escape if someone forgot to open the damper.
- ✗ Open mortar / grout at the front fireplace should be sealed.

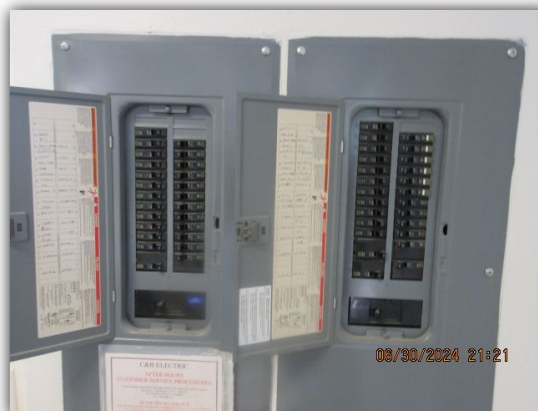
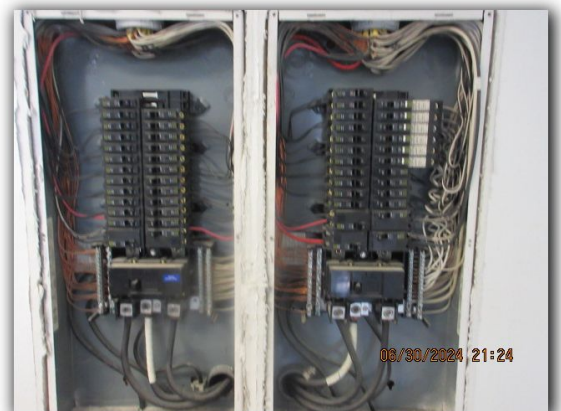
#### Deficient Items: Service Entrance and Panels

**X** Arc-fault circuit interrupting (AFCI) devices not observed at all currently required locations in the panel box. AFCI's were first required in bedrooms in January 2002. Starting in January 2008, Combination AFCI's are required in all 15-20 amp non-GFCI circuits. An arc fault is an unintended arc created by current flowing through an

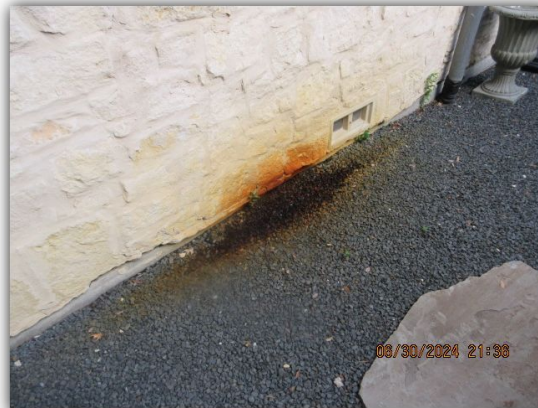
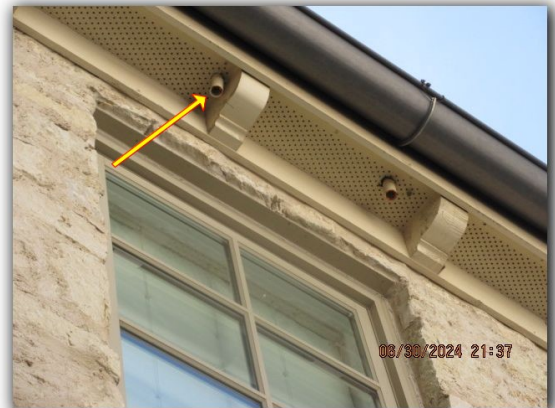
- ✗ Recommend cooling unit be checked/serviced/repared by a qualified HVAC technician.
- ✗ The attic safety secondary drain pan (2 of 3) has rust buildup but no water at this time. This indicates that the pan has held water in the past and should be closely monitored for clogged primary condensate drain line.
- ✗ The attic secondary drain pan has a rust/corrosion buildup and contains water at this time. This indicates a possible problem with the primary condensate drain line. Dripping at the secondary drain, left exterior.
- ✗ Condensing units are unlevel.
- ✗ Vegetation/debris/obstructions within 2 to 3 feet of the condensing unit needs to be removed to provide proper ventilation and improve system efficiency.

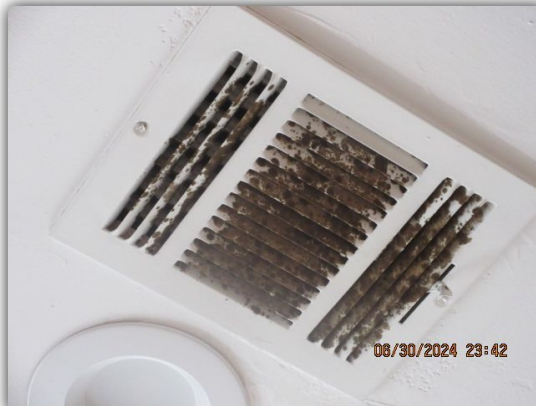
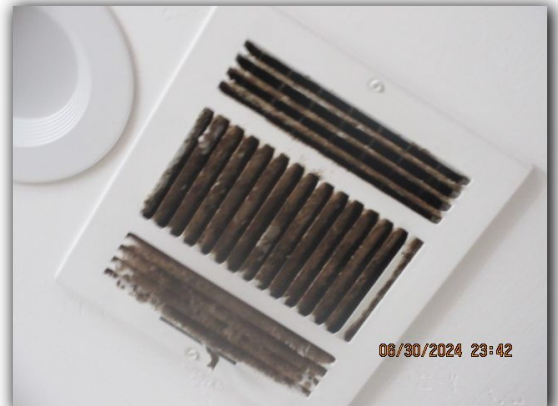
- ✗ Recommend ducts be checked/serviced/repared by a qualified HVAC technician.
- ✗ An unknown black substance and/or organism was observed on several supply registers.

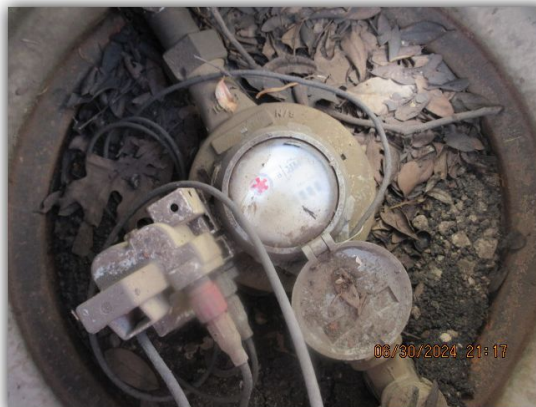
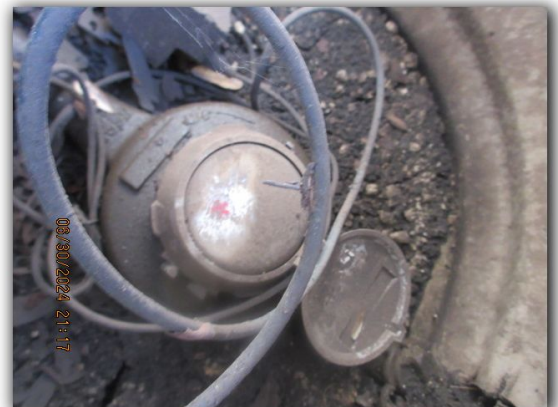
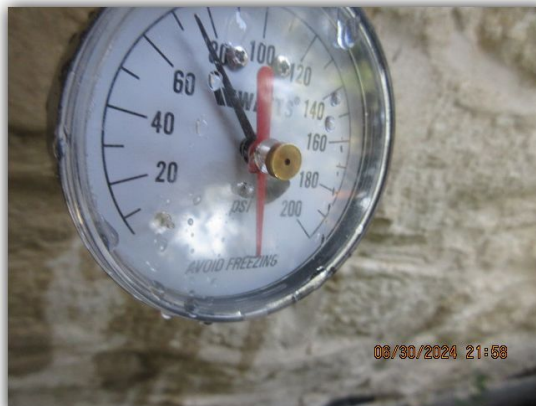
**Deficient Item(s): Plumbing Supply, Distribution System & Fixtures**

- ✗ Exterior hose faucets (left) are not equipped with backflow prevention devices that insure water only flows out and cannot siphoned back into the home.

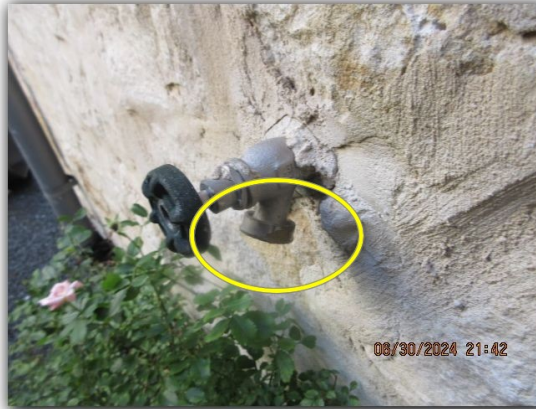
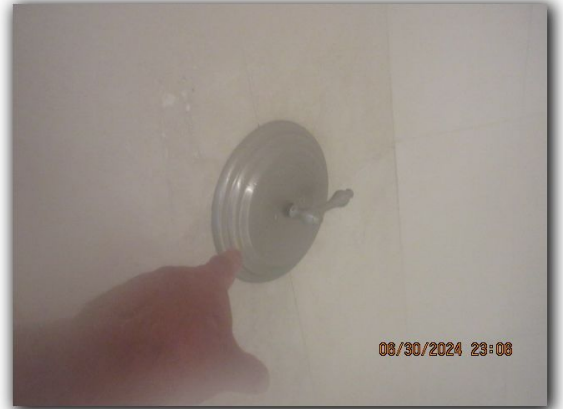
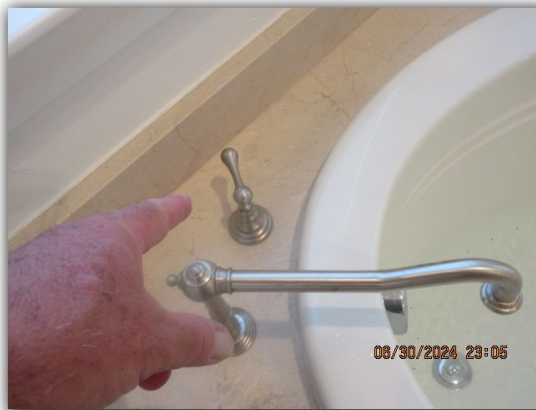
- ✗ The shower diverter is not functioning properly at the j-n-j bathtub.
- ✗ The cold water control is stuck / difficult to turn at the primary tub.
- ✗ The shower handle is loose at the primary.

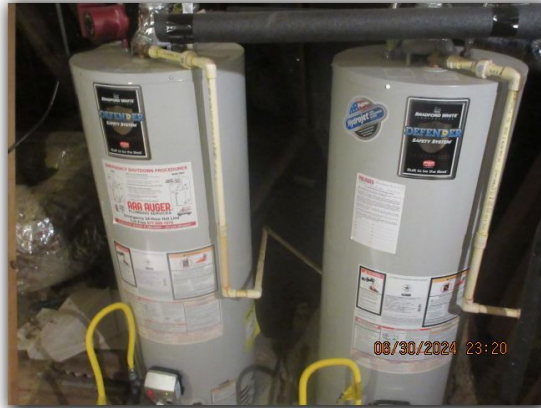
**Deficient Item(s): Water Heating Equipment**

**X** The safety drain pan contains debris that should be removed to prevent clogging the drain line.

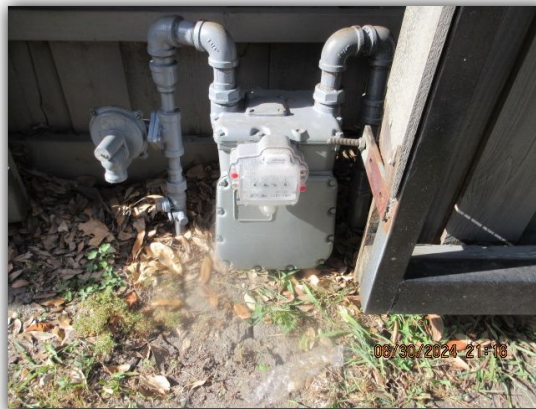
- ✓ With all pilot lights off, no dial movement observed with a 5 to 10 minute check at the gas meter.

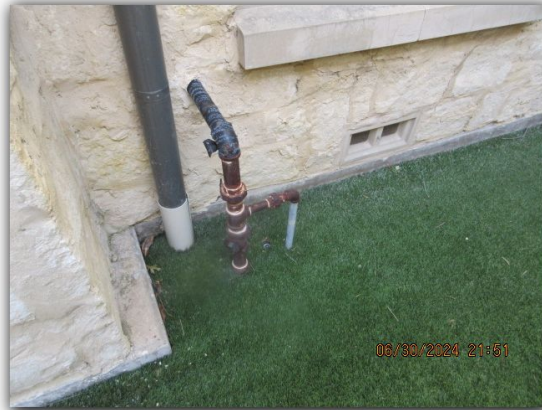
- ✗ Gas riser pipe at the right of the structure is rusted and needs to be protected with anti-rust paint.
- ✗ The gas supply line is not equipped with a sediment trap just before the gas appliance connector at the HVAC equipment.

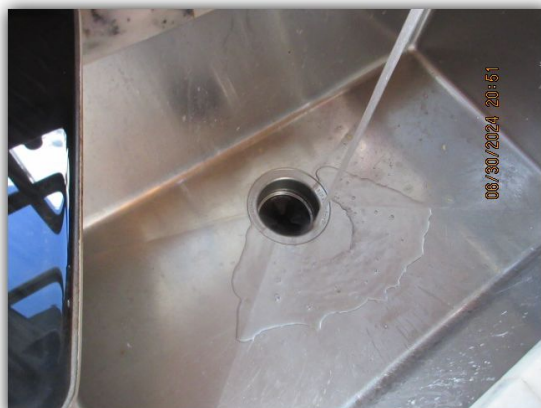
**Deficient Item(s): Food Waste Disposers**

✗ Wiring entering the disposer is not properly protected/clamped.

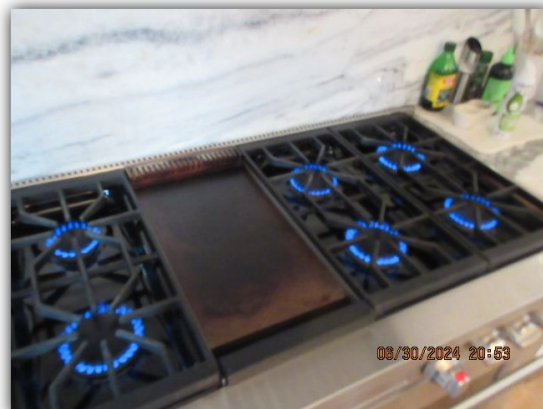
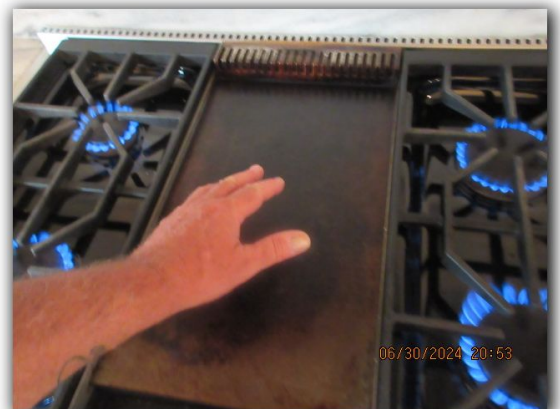
- ✓ Burners/elements are properly responding.
- ✓ The left oven produced a reading of 350 °F at a 350 °F setting in BAKE mode.
- ✓ The right oven produced a reading of 330 °F at a 350 °F setting in BAKE mode. This is within the acceptable range of  $\pm 25$  °F.

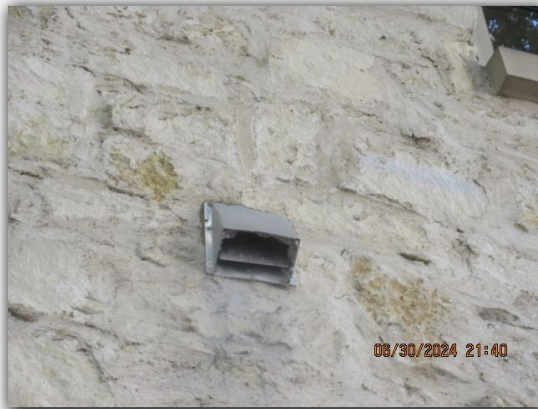
✗ The dryer vent has lint buildup and should be cleaned.
